POST-OCCUPANCY ASSESSMENT

**Massachusetts Teachers' Retirement System
500 Rutherford Avenue
Charlestown, MA**

Prepared by:
Massachusetts Department of Public Health
Bureau of Environmental Health
Indoor Air Quality Program
June 2018

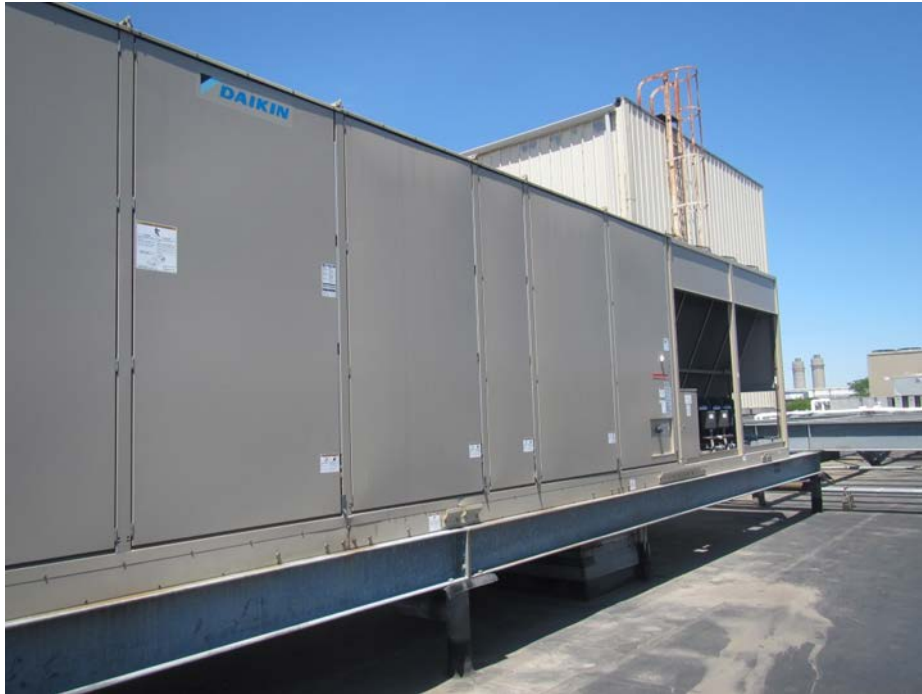
Picture 1

Fresh air is provided by rooftop air handling units (AHU) that draw fresh air from intakes on the roof (Pictures 1 and 2). The space utilizes a ducted supply system and ceiling-mounted supply vents (Picture 3). Return vents (Picture 3) draw air back into the AHU. The HVAC system was reportedly balanced prior to the November 2016 assessment. The assessment results indicate that the ventilation system is providing adequate fresh air for the occupancy in the building.

One of the two air handling units (AHU) serving the MTRS space

1. Operate supply and exhaust ventilation continuously in all areas during occupied periods. Ensure all HVAC equipment is maintained and supply and return vents are cleaned periodically to prevent dust re-aerosolization. Ensure thermostats are programmed to allow fan “on” when the building is occupied.
2. Continue to use MERV 8 filters in the AHUs and change 2-4 times a year, more often if filters are found to be heavily soiled when changed due to ambient conditions.
3. Keep plants in good condition, avoid overwatering, and remove from the airstream of heating and ventilation equipment. If allergic symptoms may be related to plants, consider removing them.

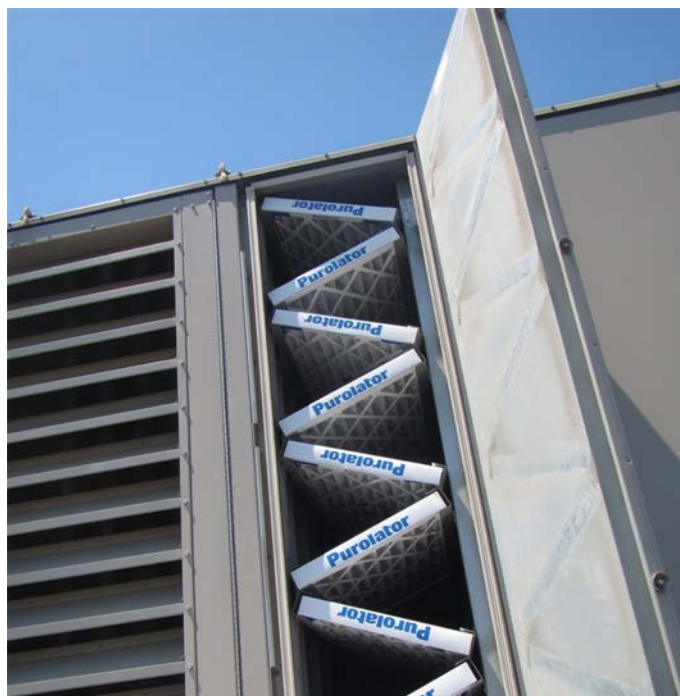
Picture 2

Occupants expressed concerns that nearby construction activities, both on the Hood campus and nearby, could be contributing to irritant symptoms in the office. The location of the specific HVAC units for this building is on the east side of the roof, which is farther away from the construction than other units in this building. At the time of the visit, background air measurements taken near the air intakes did not show elevated levels of dust (Table 1). The filters on each AHU were also examined. They have the recommended Minimum Efficiency Reporting Value (MERV) rating of 8 and fit securely in the cabinets (Picture 2). It is reported that these filters are changed several times a year. Based on these conditions, and the low levels

Filters in rooftop AHU

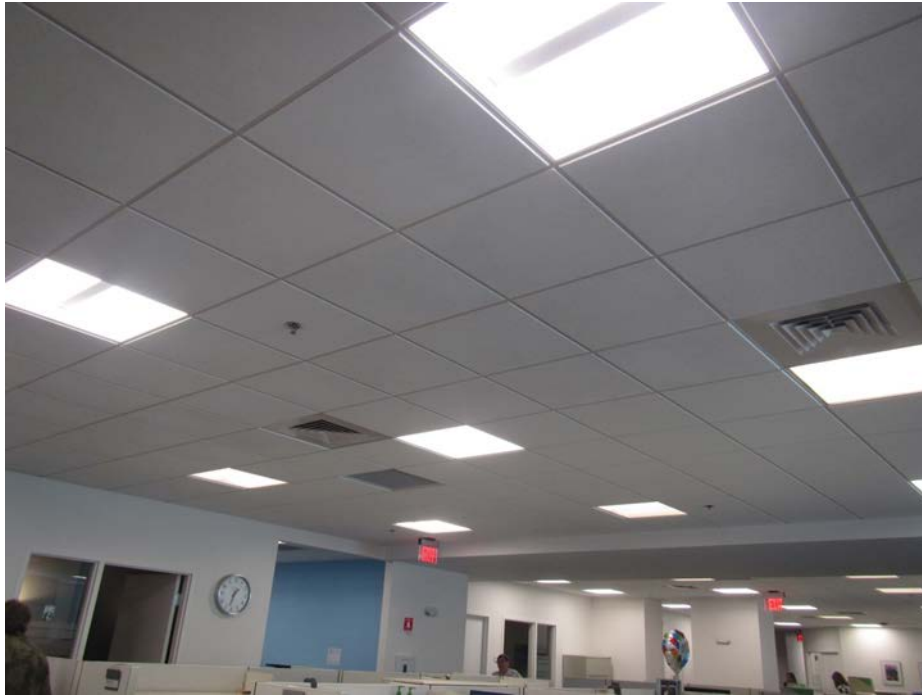
Picture 3

Supply (louvered) and return (plain grill) vents in the office space

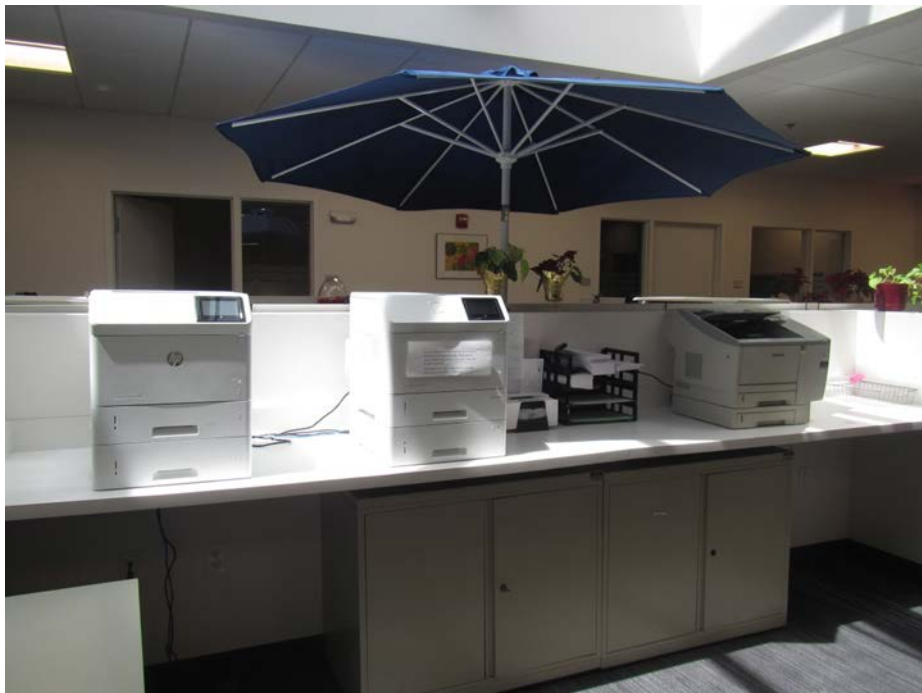
Picture 4

No water-damaged materials or other signs of water infiltration were observed during this visit. Plants were observed in a few areas (Picture 4; Table 1). Plants can be a source of pollen and mold, which can be respiratory irritants to some individuals. Plants should be properly maintained and equipped with drip pans and should be located away from air diffusers to prevent the aerosolization of dirt, pollen, and mold. Water dispensers and refrigerators were observed on carpets, where leaks can damage carpet and lead to microbial growth (Picture 5).

Plants in the office, also note sunshade under skylight

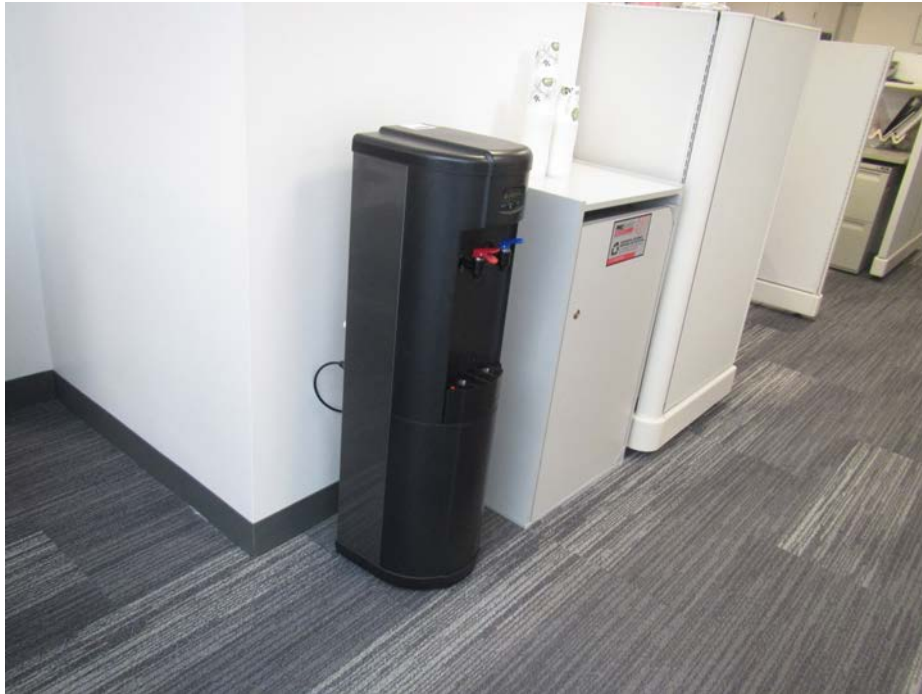
Picture 5

Water cooler on carpet

4. Consider moving water dispensers and refrigerators to areas with non-carpeted floors or use a waterproof mat underneath.
5. Reduce the use of cleaning products, sanitizers, and other items that contain VOCs.
6. Clean carpeting in accordance with IICRC recommendations (IICRC, 2012).
7. Reduce accumulated materials on flat surfaces and store in an organized manner to allow for thorough cleaning.
8. Occupants should continue to work with building management on any light-related concerns they have for this office.
9. Refer to resource manual and other related IAQ documents located on the MDPH's website for further building-wide evaluations and advice on maintaining public buildings. These documents are available at: <http://mass.gov/dph/iaq>.

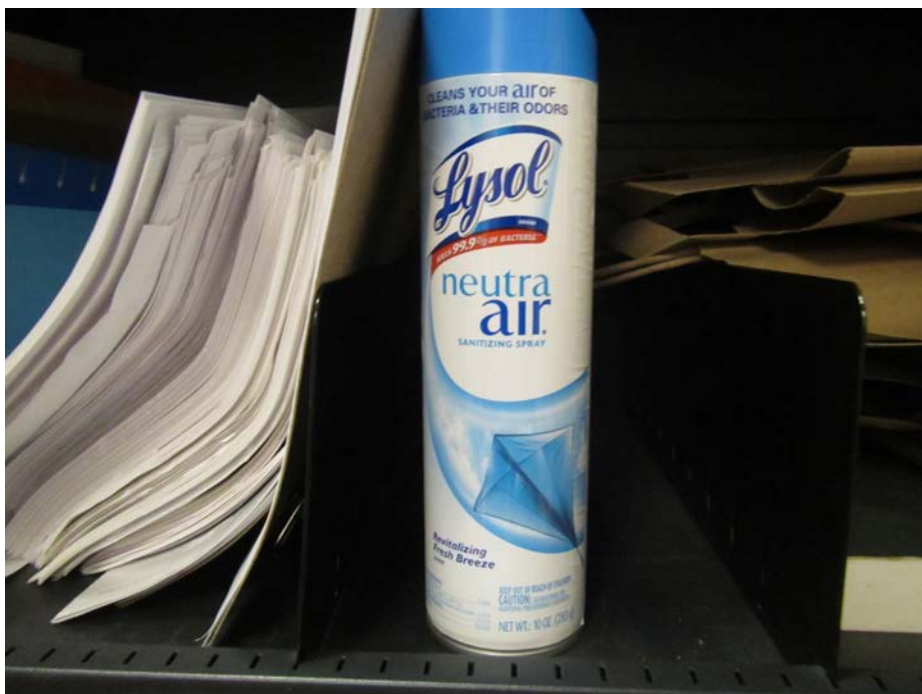
Picture 6

Exposure to low levels of total volatile organic compounds (TVOCs) may produce eye, nose, throat, and/or respiratory irritation in some sensitive individuals. In addition to testing, BEH/IAQ staff examined spaces for products containing VOCs. BEH/IAQ staff noted air fresheners, hand sanitizers, cleaning products, and dry erase materials in a number of areas throughout the office space (Picture 6; Table 1). All of these products have the potential to be irritants to the eyes, nose, throat, and respiratory system of sensitive individuals.

Air freshener
